# Photovoltaic Power Plant Inspection Report

VIčková 177, VIčková, 763 19, Česko

ORD-2026-000499

REP-2026-000158

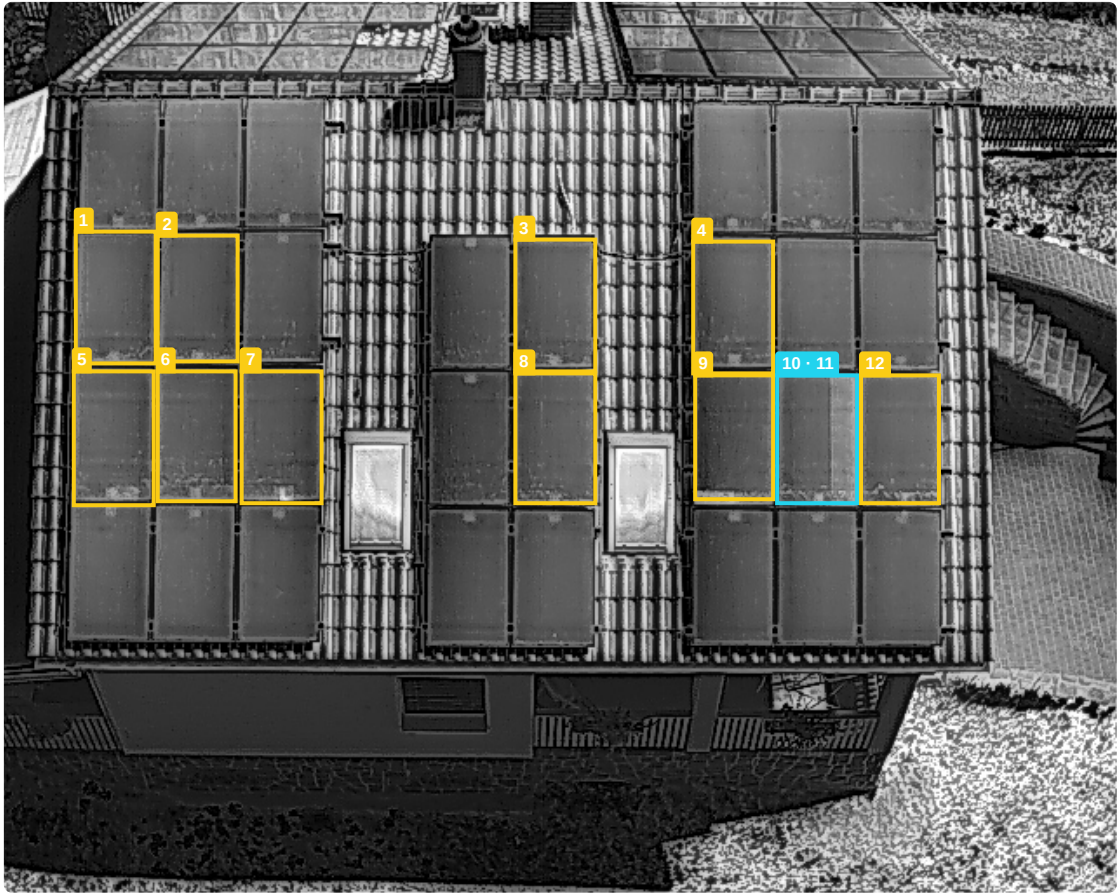
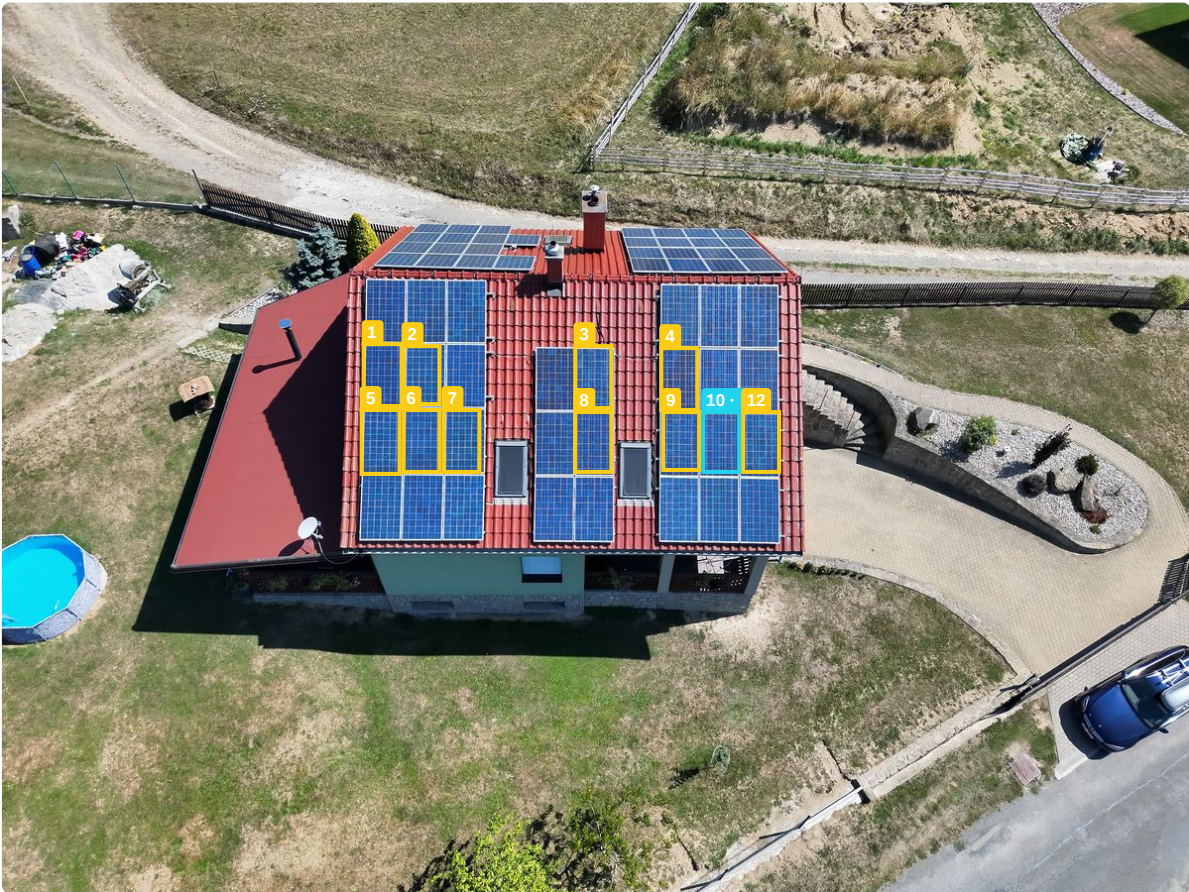
IMAGE 1/2 — INFRARED (IR) DJI\_20260811115949\_0001\_T.jpeg

- 1 Soiling
- 2 Soiling
- 3 Soiling
- 4 Soiling
- 5 Soiling
- 6 Soiling
- 7 Soiling
- 8 Soiling
- 9 Soiling
- 10 Bypass diode
- 11 Soiling
- 12 Soiling

| # | Primary Image | Secondary Image | Anomaly Name | Row | Position | AI Job | ΔT | Max °C | Min °C | Mean °C | Priority (Severity) | Recommended Next Step |
|---|---|---|---|---|---|---|---|---|---|---|---|---|
| 1 | | | Soiling | 2 | 1 | AIR-2026-001077 | 3.9 | 44.5 | 21.7 | 41.2 | Low | Repair |
| 2 | | | Soiling | 2 | 2 | AIR-2026-001077 | 3.8 | 44.5 | 19.9 | 41.2 | Low | Repair |
| 3 | | | Soiling | 2 | 5 | AIR-2026-001077 | 7.5 | 47.9 | 19.0 | 42.1 | Low | Repair |

| # | PRIMARY<br>IMAGE | SECONDARY<br>IMAGE | ANOMALY<br>NAME | ROW | POSITION | AI JOB | ΔT | MAX<br>°C | MIN<br>°C | MEAN<br>°C | PRIORITY<br>(SEVERITY) | RECOMMENDED<br>NEXT STEP |
|---|---|---|---|---|---|---|---|---|---|---|---|---|
| 4 | | | Soiling | 2 | 6 | AIR-2026-001077 | 3.5 | 44.0 | 15.5 | 41.3 | Low | Repair |
| 5 | | | Soiling | 3 | 1 | AIR-2026-001077 | 5.3 | 45.8 | 19.9 | 41.6 | Low | Repair |
| 6 | | | Soiling | 3 | 2 | AIR-2026-001077 | 3.9 | 44.3 | 20.0 | 41.5 | Low | Repair |
| 7 | | | Soiling | 3 | 3 | AIR-2026-001077 | 11.3 | 52.8 | 19.9 | 41.0 | Low | Repair |
| 8 | | | Soiling | 3 | 5 | AIR-2026-001077 | 6.4 | 47.0 | 20.4 | 41.9 | Low | Repair |
| 9 | | | Soiling | 3 | 6 | AIR-2026-001077 | 7.0 | 47.6 | 19.6 | 40.3 | Low | Repair |
| 10 | | | Bypass diode | 3 | 7 | AIR-2026-001077 | 6.4 | 47.0 | 20.9 | 43.1 | High | Monitoring |
| 11 | | | Soiling | 3 | 7 | AIR-2026-001077 | 6.4 | 47.0 | 20.9 | 43.1 | Low | Repair |
| 12 | | | Soiling | 3 | 8 | AIR-2026-001077 | 6.3 | 47.5 | 22.6 | 43.1 | Low | Repair |

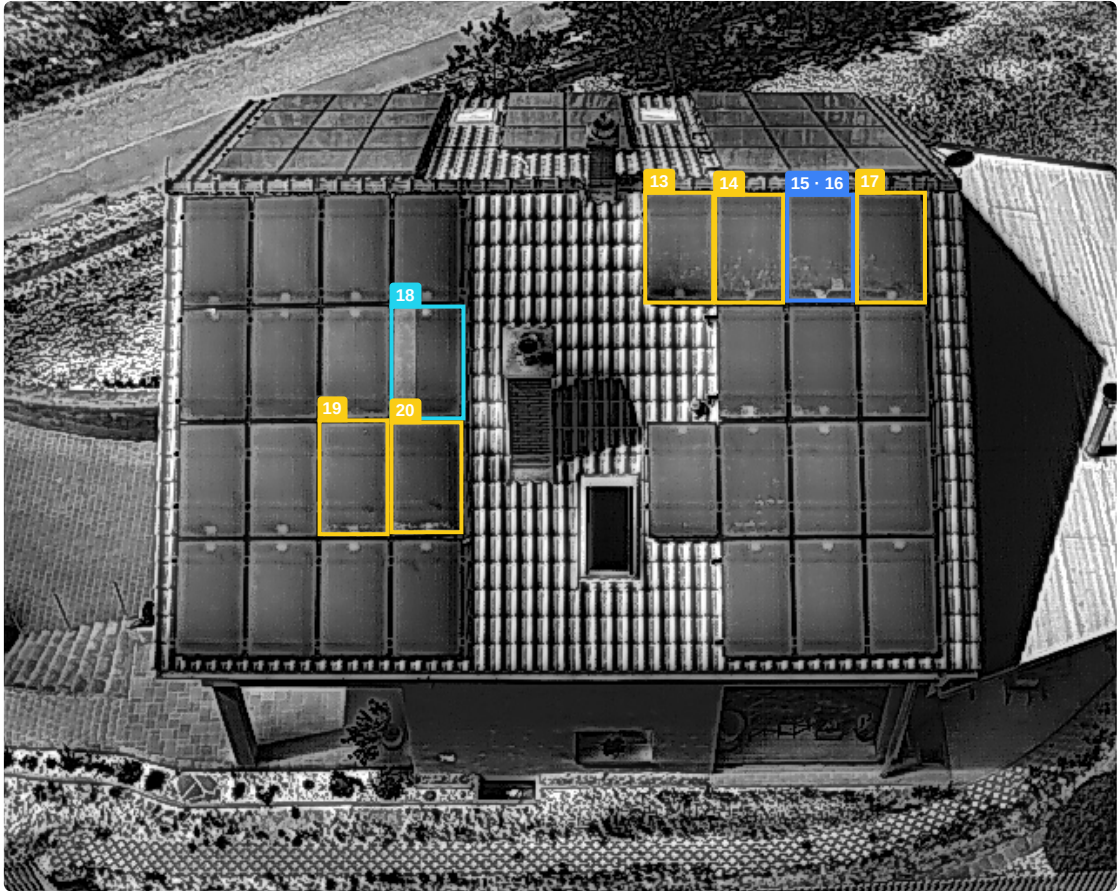
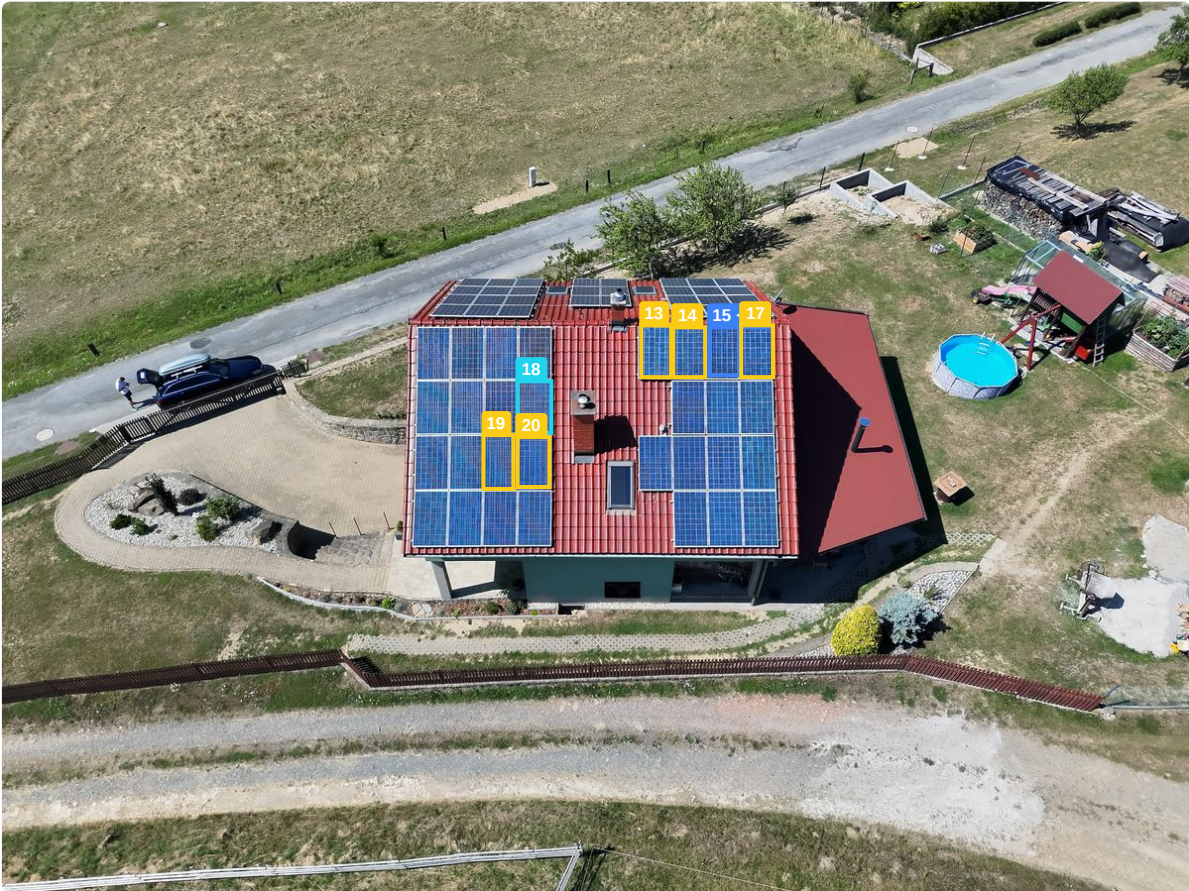
VISIBLE LIGHT (RGB) DJI\_20260811120009\_0003\_V.jpeg

13 Soiling 14 Soiling 15 Cell overheating 16 Soiling 17 Soiling 18 Bypass diode 19 Soiling 20 Soiling

| # | PRIMARY<br>IMAGE | SECONDARY<br>IMAGE | ANOMALY<br>NAME | ROW | POSITION | AI JOB | ΔT | MAX<br>°C | MIN<br>°C | MEAN<br>°C | PRIORITY<br>(SEVERITY) | RECOMMENDED<br>NEXT STEP |
|---|---|---|---|---|---|---|---|---|---|---|---|---|
| 13 | | | Soiling | 1 | 5 | AIR-2026-001078 | 11.4 | 51.7 | 22.5 | 42.3 | Low | Repair |
| 14 | | | Soiling | 1 | 6 | AIR-2026-001078 | 5.2 | 45.6 | 17.1 | 43.0 | Low | Repair |
| 15 | | | Cell overheating | 1 | 7 | AIR-2026-001078 | 6.9 | 47.4 | 20.0 | 42.5 | Medium | Monitoring |
| 16 | | | Soiling | 1 | 7 | AIR-2026-001078 | 6.9 | 47.4 | 20.0 | 42.5 | Low | Repair |
| 17 | | | Soiling | 1 | 8 | AIR-2026-001078 | 3.7 | 44.0 | 19.8 | 39.3 | Low | Repair |

| # | PRIMARY<br>IMAGE | SECONDARY<br>IMAGE | ANOMALY<br>NAME | ROW | POSITION | AI JOB | ΔT | MAX<br>°C | MIN<br>°C | MEAN<br>°C | PRIORITY<br>(SEVERITY) | RECOMMENDED<br>NEXT STEP |
|---|---|---|---|---|---|---|---|---|---|---|---|---|
| 18 | | | Bypass diode | 2 | 4 | AIR-2026-001078 | 6.4 | 46.8 | 12.2 | 40.6 | High | Monitoring |
| 19 | | | Soiling | 3 | 3 | AIR-2026-001078 | 5.1 | 45.6 | 19.0 | 42.1 | Low | Repair |
| 20 | | | Soiling | 3 | 4 | AIR-2026-001078 | 5.2 | 46.0 | 15.2 | 38.7 | Low | Repair |
